Almost Killed by a Practice Bomb

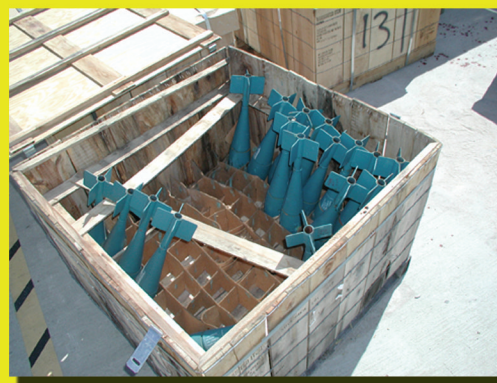
This bomb-storage crate belies how bad the damage was.

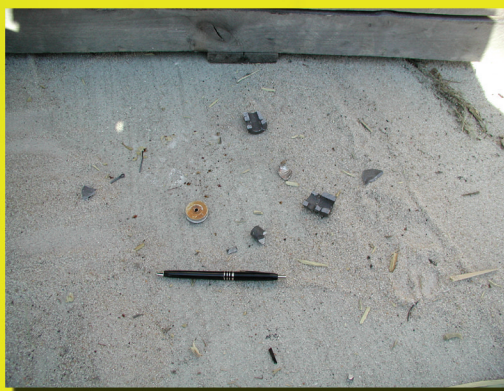
Bomb fragments and debris littered the area around the mishap site.

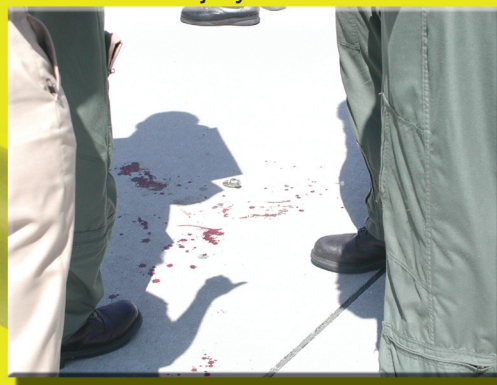
A blood trail led from the bomb build-up area and is a clear sign of a serious injury.
